REPORT FOR ANALYSIS

2019FM14309R01Ea

ROCKUBOT

Name of Sample	ROCKUBOT	Test Type	Entrustment Test			
Applicant	Shenzhen Phontron Technology Co., Ltd.	Address	Rm 1406, 14/F, Tower C, Building 9, Baoneng Science & Technology Park, Qingxiang Road, Longhua District, Shenzhen, China			
Sample Source	Submitted for Testing by the Applicant	Sample Quantity	1PCS			
Spec and Lot № of Sample	PT011	State and Characteristic	Solid			
Sample Received Date	2019-10-08	Test Completion Date	2019-10-14			
Test Standard and Method	Technical Standard for Disinf	fection (2002 Ministr	y of Health P.R.China)- 2.1.5.4			
Item Tested	Validation of disinfection ef	ficacy of sterilization Ultraviolet light	and disinfection instruments:

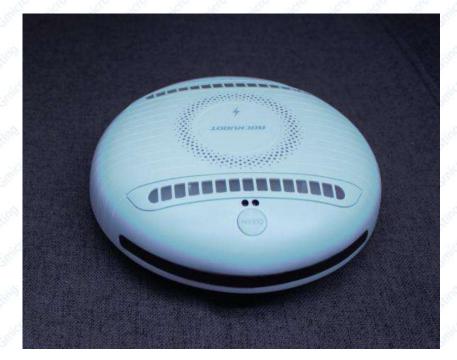
Sample Picture

1. Sample pretreatment: Take glass as the carrier, the action time is 6s and the action distance is 2cm.
